TSD-02-001

April 29, 2002

Customer Complaints for Vibration -Tire/Rim Slip-

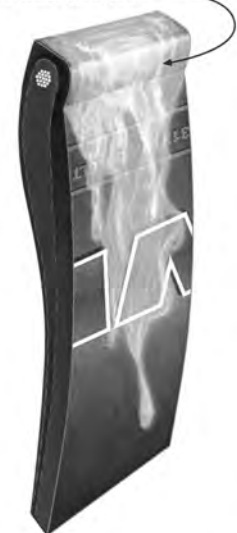
The main cause of tire/wheel slip is excessive use of tire lubricant (shown on the right) on the tire beads and rim. Excessive lubricant reduces friction between the tire bead and the wheel, allowing the tire to slip within hours of mounting.

INCORRECT APPLICATION
OF LUBRICANT

1. For new tire and wheel assemblies, clean the tire beads of any manufacturing related lubricants with an approved rubber cleaner fluid commonly used in the tire repair process.
2. Clean the wheel bead seating area.

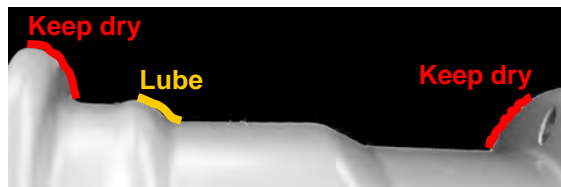
High performance, low profile passenger tires mounted on European-made alloy wheels may require higher mounting pressures, as bead seat tolerances may be tighter than domestic wheels. Additional lubrication of the safety hump (as shown below) may be required to facilitate bead seating.

4. If more than 40 psi is required to seat the beads, dismount the tire, re-lubricate and repeat the process. Always follow the advice of the tire and wheel manufacturer regarding maximum pressure.
5. Index the wheel valve stem to some location on the tire sidewall so that slippage can be confirmed in the event of a customer return for vibration.
6. In the event of a customer complaint where tire/wheel slip has occurred, remove the old weights and re-balance the assembly. Do not dismount the tire unless there is a requirement to match-mount the assembly.

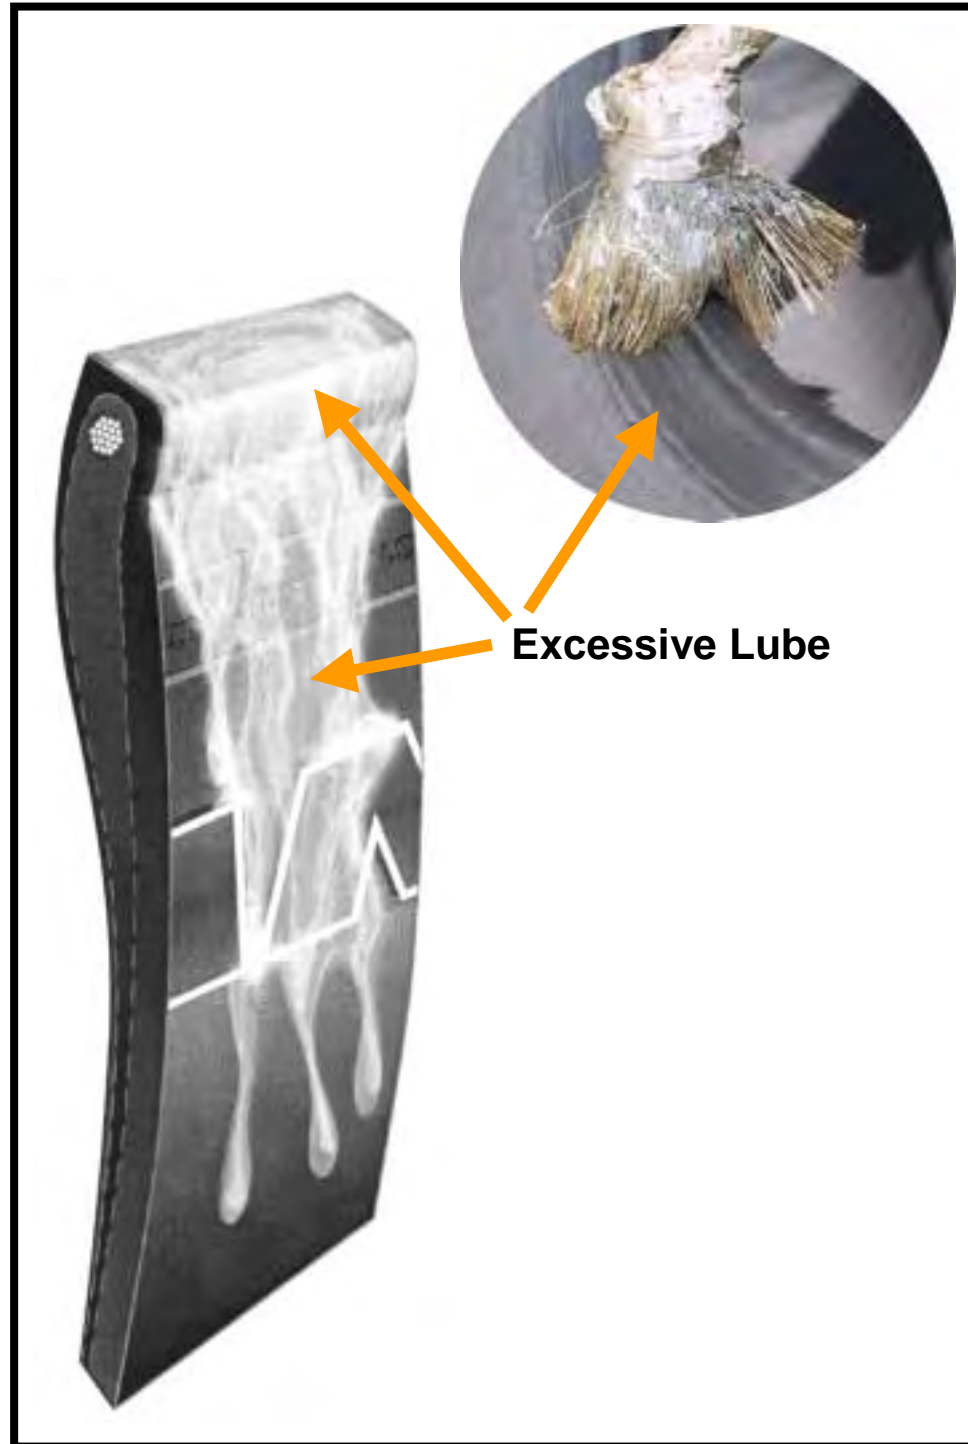
Incorrect

Over-lubrication Will Cause Tire/Rim Slip
